Wyoming Wildlife Crossing Scan Tour

Report by: Jason Richins, Monte Aldridge, Randal Taylor, Larry Johnson, and Paul West

On June 30, 2015, UDOT and UDWR met with Wyoming DOT and Wyoming Game and Fish to tour their new wildlife crossings. The almost \$10 million project was substantially complete in October of 2012. The project constructed 6 underpasses and 2 overpasses and put in wildlife fence and escape ramps over a 12-mile section of US 189/191, west of Pinedale, Wyoming. US

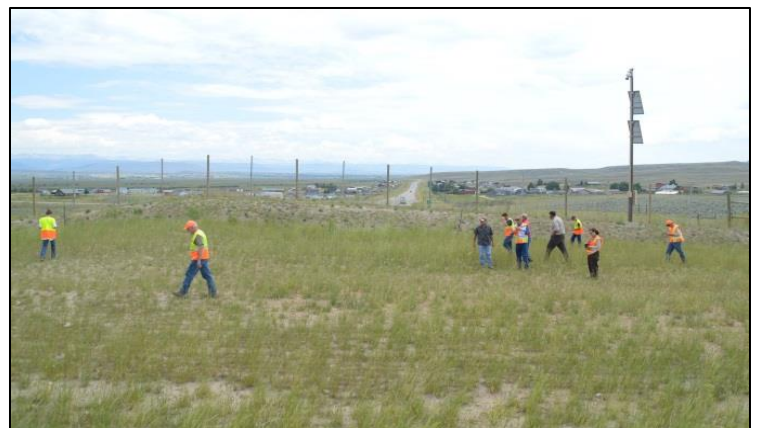
Figure 1 -1 Trappers Point Overpass looking SB on US 191

The overpass at Trappers Point is a 152' wide arch structure. Contech designed the arches and Old Castle precast the pieces. During multiple 15 minute closures, two cranes swung the half arch precast sections into place over the US 191. The pieces were the bolted together. It took about a week to place all the arch pieces. 8' high berms we added on each side of the arch to limit the animal's view of vehicles on the roadway below. Trappers Point also has a camera so that the public can

The trappers point location was selected for the overpass due to the major pronghorn migratory path that crossed in that location. Designers had hoped to use some hills next to the roadway to allow the pronghorn to see the path across the structure. That wasn't possible since some archeological sites are in the area. Instead the overpass was built with a large hump of the structure in the middle. Since this was one of the first wildlife

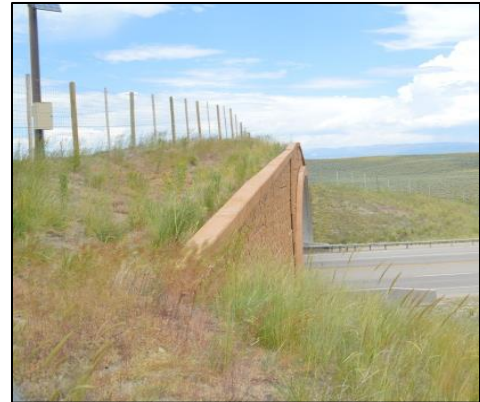
Figure 1-2 Trappers Point Overpass

The overpasses cost approximately \$1.7 million each. A lot of fill was needed at the Trappers Point location in order to have slopes that would be more welcoming to the pronghorn.

9) The overpasses are covered with minimum of 3-ft of select and soil cover above the concrete arches is a good amount. Part of the reason is to allow for increased soil moisture to sustain vegetation.

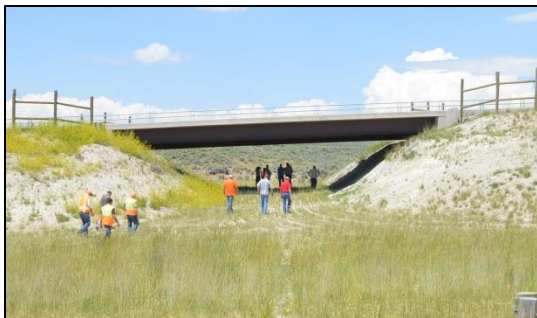
Figure 2-1 Underpass #5 US 191

The underpass structures are 70 foot long, 43 foot wide, simple spans made with weathering steel rolled I-beams. There are 6 underpasses constructed on the project and all were designed the same to save money. They also were able to reuse the construction forms on each of the bridges.

The underpasses cost about \$350 thousand each.

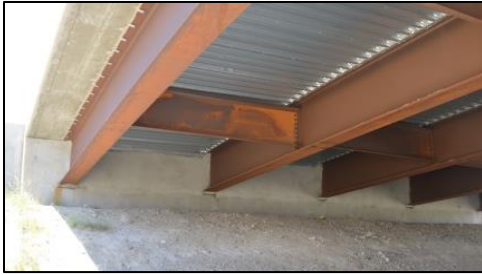
Figure 2-2 Underpass #5 Weathering steel rolled I-beams

Weathering steel was used for the girders which reduces the maintenance on the girders since there isn't paint to maintain. The stay in place forms were used to reduce forming on the underside of the deck. The corrugations of the stay in place forms were filled with foam prior to pouring the deck to reduce the amount of concrete in the deck.

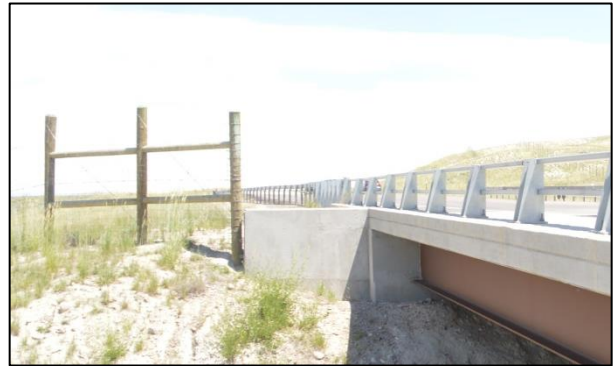
Figure 2-3 Underpass #5, Straight section of wing wall used as another wildlife escape ramp

The project placed wildlife escape ramps every $\frac{1}{4}$ to $\frac{1}{2}$ miles in the 8' wildlife fence sections. In Figure 2-3, WYDOT allowed additional wildlife escape ramp at the wingwalls of the bridges. Wildlife can jump down at the wingwalls but not back up.

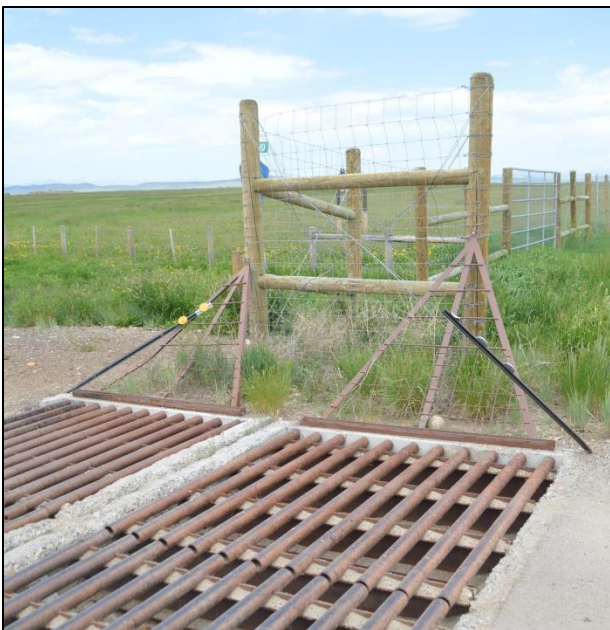
Figure 3-1 Double Cattle Guard

WYDOT pointed out to us that deer are getting around the ends of the double cattle guards by jumping over the angled ends sections and landing in the flat area between the angled end sections. They discussed wanting to make a custom angled end section that wouldn't have the gap between the two angled end sections. Or another possible solution was to bring the fence right up to the cattle guard and not use the angled end sections.

We will stay in touch with WYDOT and monitor this issue.

8) Much of the breaching of the wildlife fencing project by ungulates is at the double cattle guards where animals are either jumping into the concrete landing pad between the two cattle

guards, or are jumping through the wings and the ends. An improved single wing across both cattle guards is anticipated to be implemented.

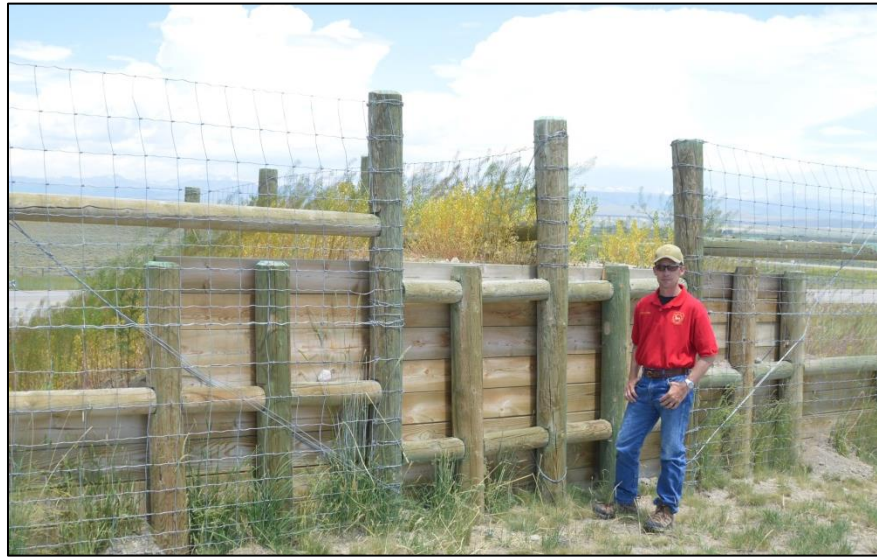
Figure 3-2 Wildlife Escape Ramp at Trappers Point

WYDOT mentioned that they have had a little bit a trouble at some locations of large deer jumping in and out of the ROW at the escape ramps. They don't have a standard drawing for their wildlife escape ramps. In Figure 3-1, WYDOT's wildlife escape ramps resemble UDOT's wildlife escape ramps STD DWG FG 4A. We didn't visit the specific sites where the deer are jumping in and out from the wildlife escape ramps.

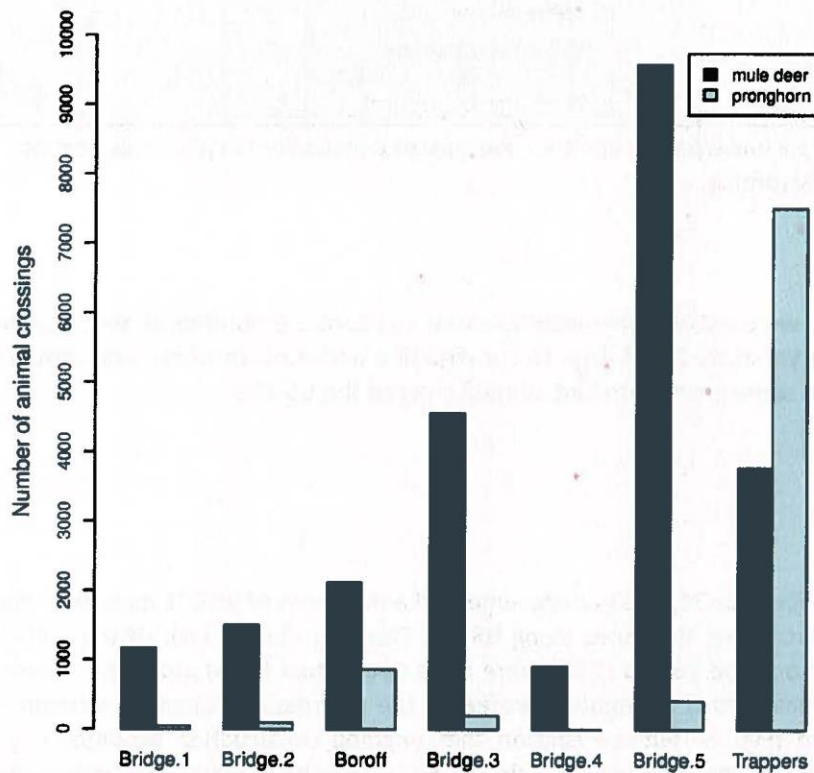
Between October 1 and December 31, 2013 we documented a minimum of 36,071 mule deer and pronghorn move through the new crossing structures along US 191 (Table 1; Photos 1-3). Of the 36,071 animals, 9,228 (26%) were pronghorn and 26,843 (74%) were mule deer. Most (80%) mule deer moved through underpasses, whereas most (90%) pronghorn preferred the overpasses. Crossing structures received differential levels of use (Fig. 2), but we caution that ongoing construction activities (e.g., earthwork, fencing, etc.) and livestock containment (i.e., closed gates) may have influenced animal use at several locations. Nonetheless, Bridges #3 and #5 were more heavily used than the other underpasses. Similarly, the overpass at Trapper's Point received more use than the Boroff overpass. In

Figure 2. Number of mule deer and pronghorn crossings at each structure, October 1, 2012 through December 31, 2013.

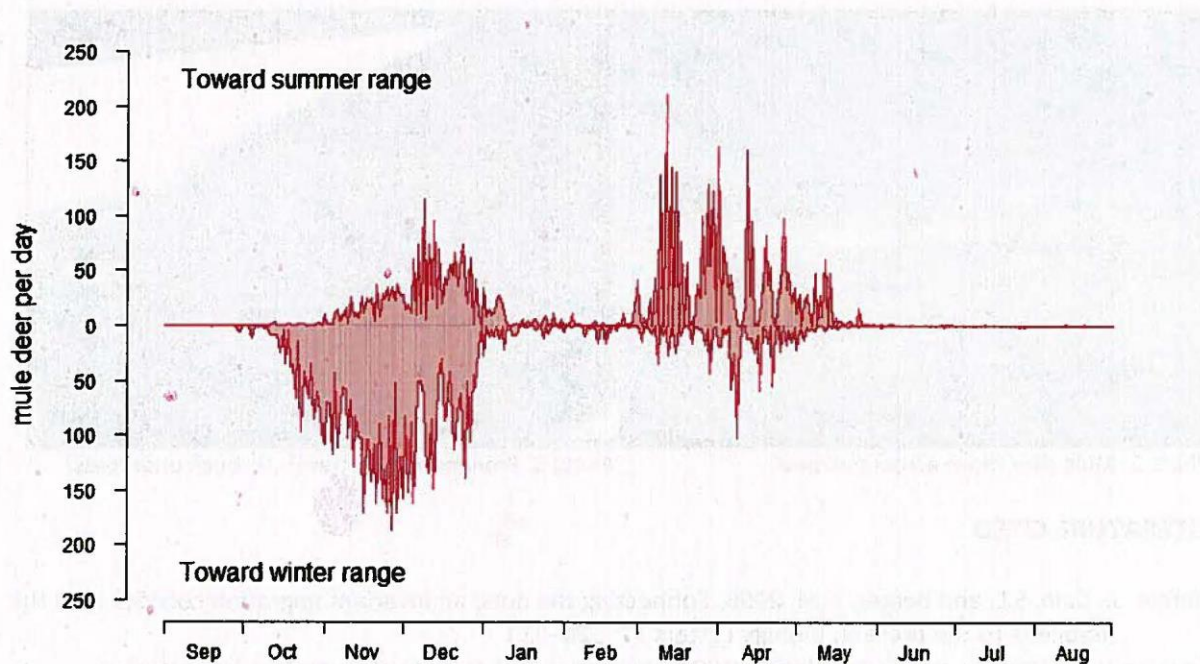
general, the structures near Trapper's Point, or east of Daniel Junction had higher levels of use compared to those north of Daniel Junction. It is worth noting that most of the structures east of Daniel Junction are being used by animals year-around and not limited only to migration periods. And, we have documented a surprising amount of back and forth movement during migration periods, especially for mule deer during the fall (Fig. 3). These trends will be examined more closely in the final report.

Figure 3. Average number of mule deer crossings by month and direction, October 1, 2012 through December 31, 2013.

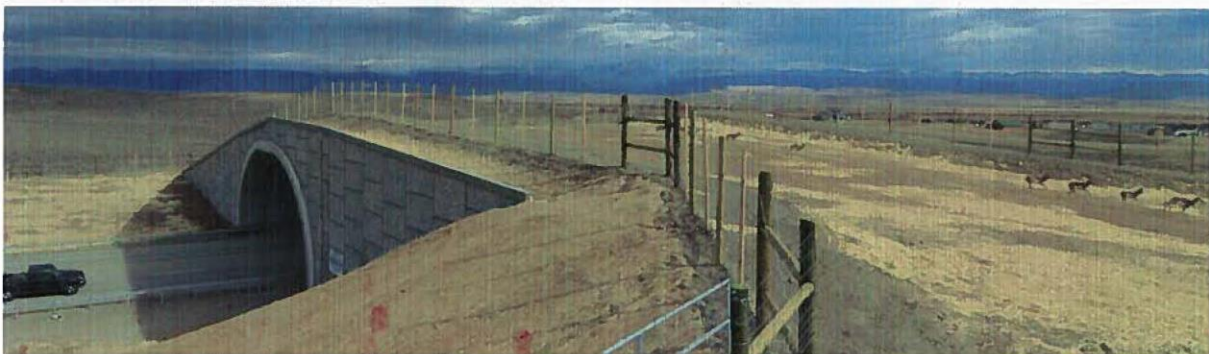
Photo 1. Pronghorn move across Trapper's Point overpass (photo Joe Riis).

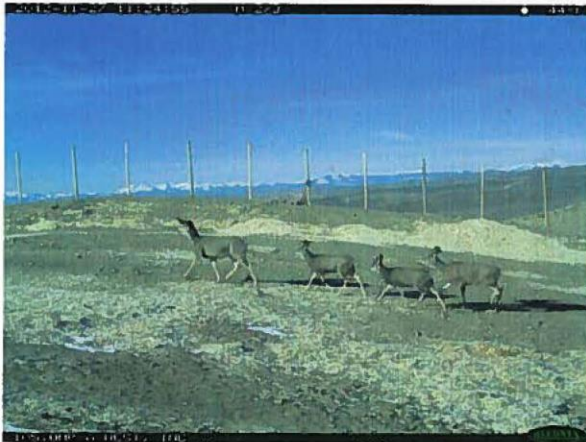
Photo 2. Mule deer move across overpass.

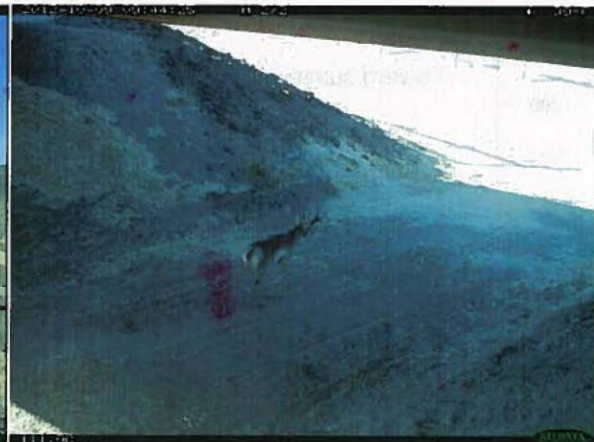
Photo 3. Pronghorn buck travels through underpass.
